ASIA CONSTRUCT CONFERENCE

14-15 November 2013

Japan Theme Paper

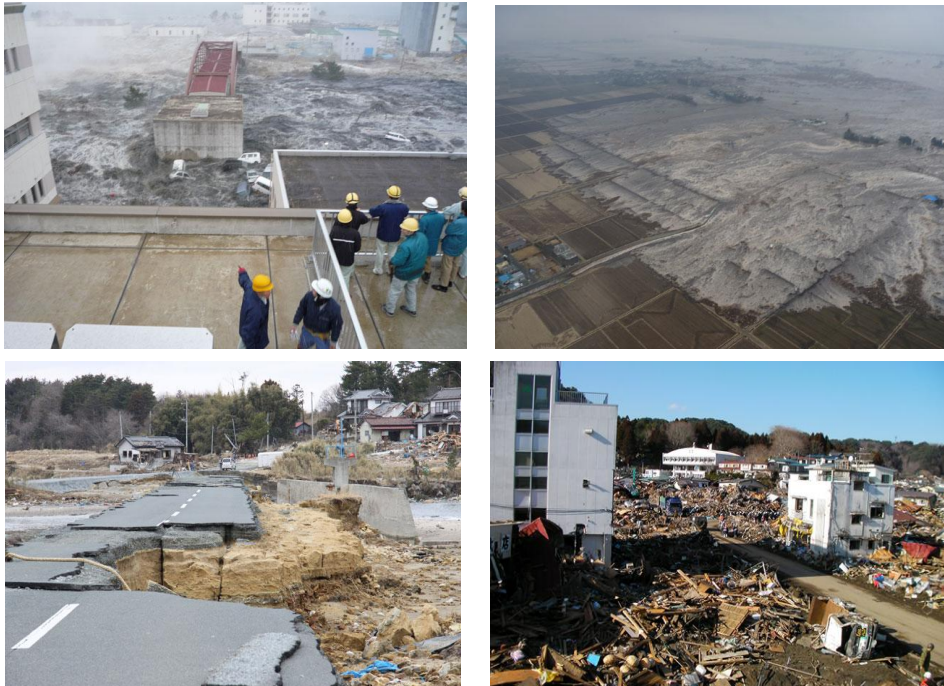
Figure 4: Damage status ②

The Great East Japan Earthquake was the largest in recorded history of Japan, and as this earthquake triggered a tsunami, the damages were extensive. The total area flooded by the tsunami was 561km², and as of February 2013, the total number of fatalities was 15,883 and 2,656 persons are still listed as missing. In addition, 126,483 homes were completely destroyed, 272,287 were partially destroyed, and infrastructure such as roads and waterways were extensively damaged.

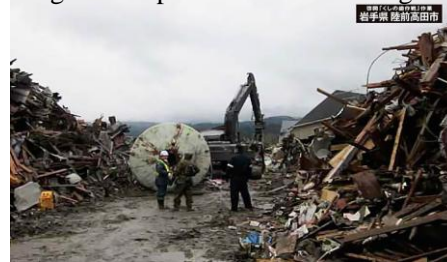
Figure 6: Operation Comb in Progress

“Operation Comb” involved the opening up of multiple routes from the Tohoku Expressway and National Route No.4, which run north to south in the inland areas of the North-Eastern, to the various national routes that run along the coastal areas, like the teeth of a comb, in order to secure rescue and relief routes.

Due to the unimaginable size of the tsunami, the regions along the Pacific coast suffered catastrophic damage and became isolated due to the amounts of debris generated by the disaster. In order to secure emergency routes to the coastal areas, prefectural staff, the Ground Self-Defense Force, construction companies and personnel from the Ministry of Land, Infrastructure, Transport and Tourism, worked together to break through this debris, and had opened 11 routes by the day after the disaster (12th) and 15 routes by the 15th. This enabled passage for ambulances, and police and self-defense force vehicles, allowed medical teams to gain access to the affected areas, and enabled the distribution of relief supplies.

The reason why this opening of routes was concluded in such a short time is that, following the damage to roads observed after the Great Hanshin-Awaji Earthquake of 1995, the Tohoku region implemented a seismic reinforcement measures on 490 bridges, and this was a significant factor that contributed to the avoidance of life-threatening damages such as collapsed bridges.

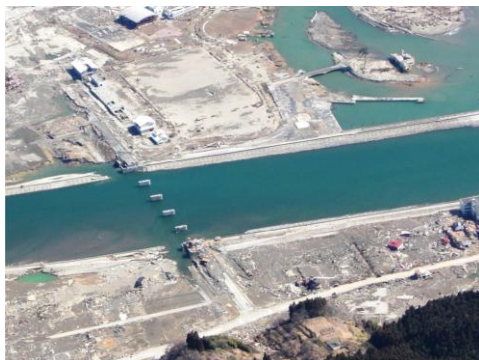
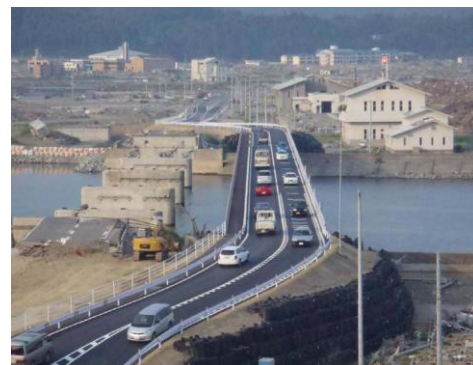
Figure 7: Emergency recovery of Bridge (Rikuzen-Takata City, Iwate Prefecture)

(Damage status)

After emergency recovery (July 12, 2011)

Construction companies commenced work immediately after the earthquake and proceeded vigorously in the recovery of facilities such as roads, ports/harbours, airports, railways and waterways, etc. In addition, with regards to emergency provisional housing, at the time of the disaster, local authorities estimated the need for such housing at 52,000 units. In the construction of emergency provisional housing, local construction companies, as well housing manufacturers, sought to meet the demand, with 4,000 units built by construction companies, 1,300 units built by the Fukushima General Construction Association and 2,700 units built by another 11 construction companies. After about 6 months from the disaster, construction of 51,000 of the required 52,000 housing units had been completed.

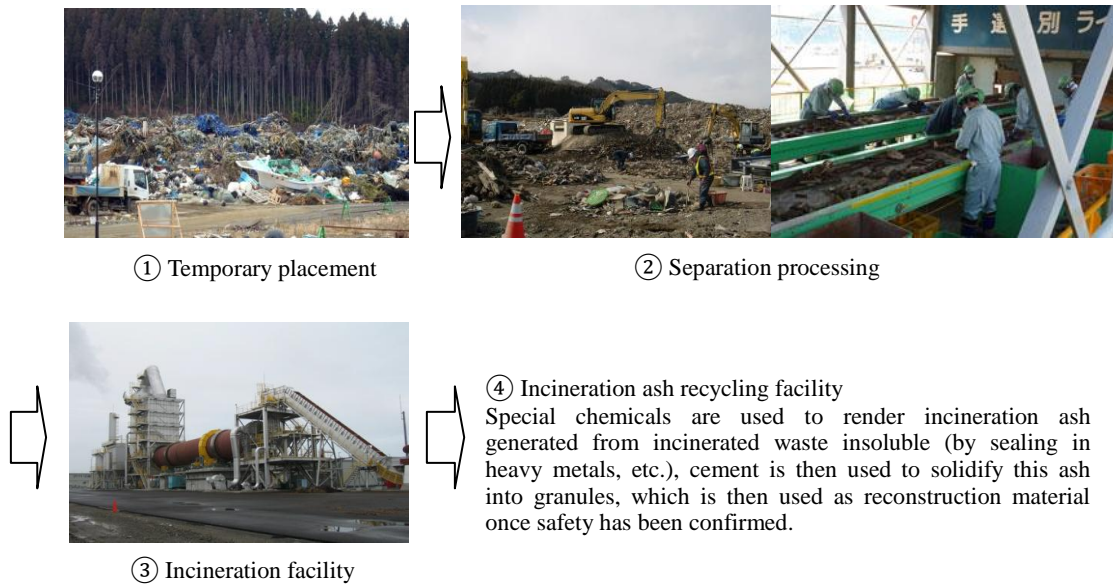
Figure 10: Flow of disaster waste processing

For processing, the general procedure was to dismantle waste at the disaster sites, and then to transport the waste to initial temporary placement sites for rough sorting and rough crushing. This waste was then collected and transported to a secondary temporary placement site for intermediate processing (crushing, sorting, incineration, etc.), finally followed by recycling and disposal.

Joint ventures (JV) have been commissioned to undertake each disposal classification in this series of processing, and the construction companies that possess the wide ranging know-how to cover the establishment of waste disposal facilities, the improvement of foundations, the removal of various toxic wastes and responses to radiation, and recycling technologies, form the core of these JVs.

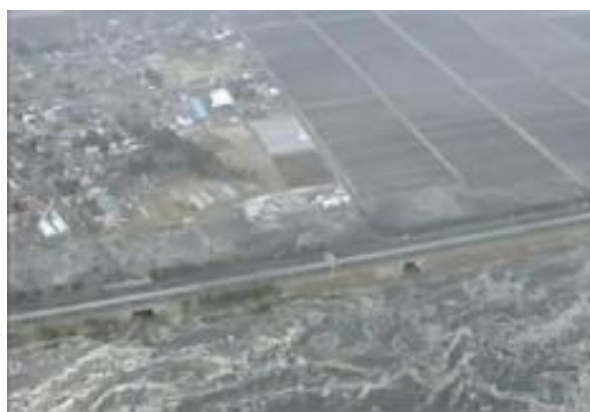
Figure 12: Disaster mitigation by the “Sendai-Tobu Road”

This road was built on an earthen embankment (7-10m), and about 230 persons evacuated themselves toward this road as a shelter, and they have escaped the tsunami. This highway structure also demonstrated a preventive function by inhibiting the flow of the tsunami and debris from penetrating into inland areas.

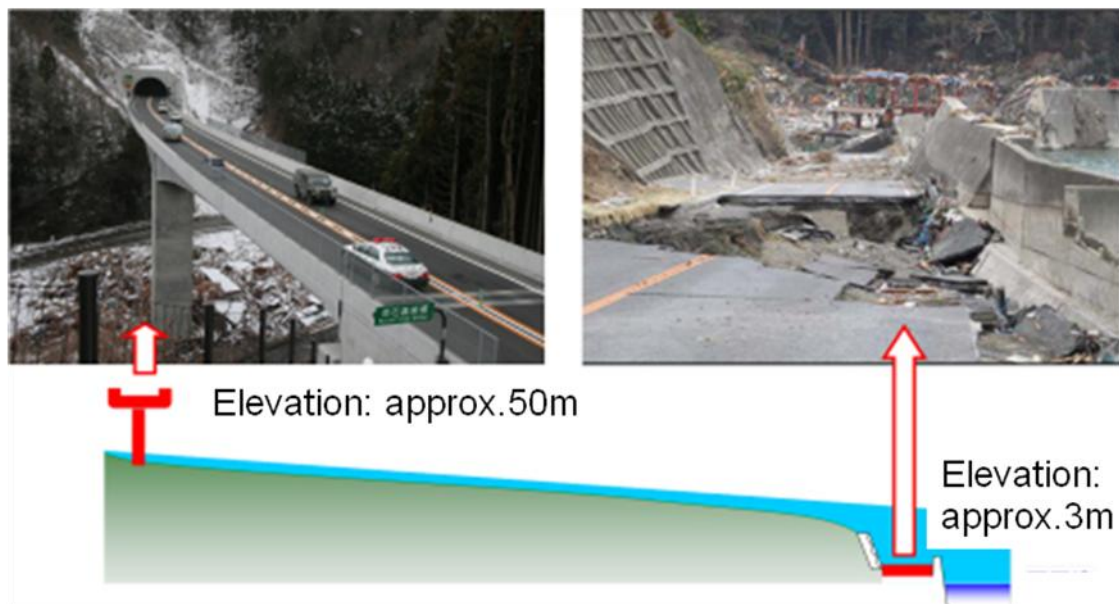
Figure 13: Sanriku Expressway
Sanriku Expressway **National Route No.45**

The Sanriku Expressway was not damaged by the earthquake or tsunami as its route was planned on high ground following consideration of a past tsunami, and consequently contributed greatly to emergency transportation, etc. and played as an alternative logistics network during the reconstruction stage.

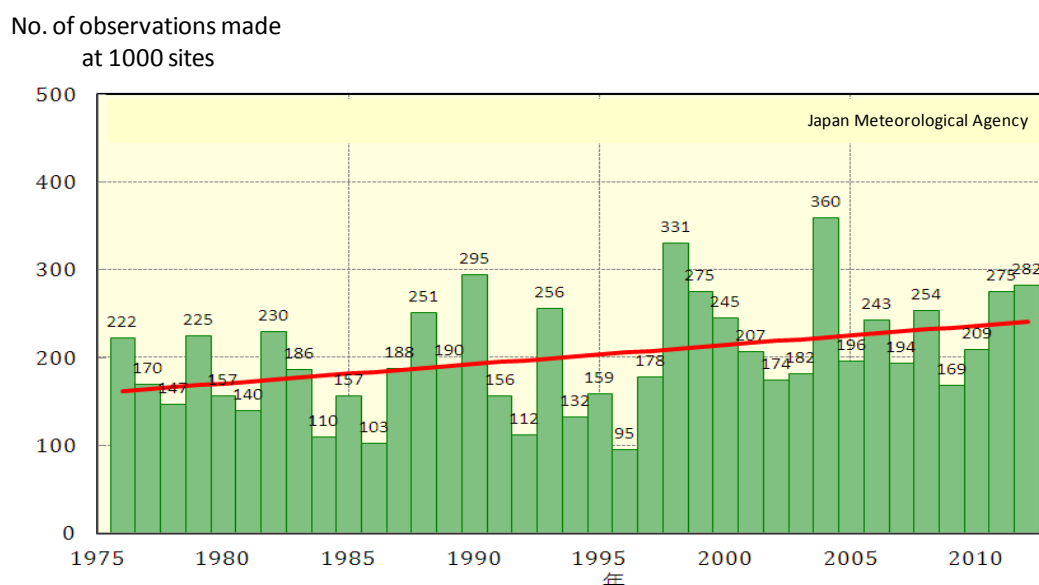
Figure 15: No. of times rainfall greater than 50mm/hour has been observed over one year

The land structure of Japan is a long thin shape with a mountainous region running all the way through the middle of the archipelago. As 70% of national land is either mountainous or hilly, the terrain is precipitous and there is little sufficiently wide flat land available for habitation. Furthermore, rainfall is concentrated in the monsoon and the typhoon season, so flooding and landslides can easily occur. In recent years, the frequency of short-burst concentrated downpours has increased, and this has heightened the danger of flooding and landslides occurring. For the future, as the IPCC presides, temperature increases, greater frequency of heavy rains, increased intensity of typhoons, rising sea levels, and greater fluctuations in rainfall, etc. are expected.

Furthermore, when looking at changing trends in the incidence of short-burst downpours with over 50ml/hour rainfall and heavy rains of more than 200ml/day, both

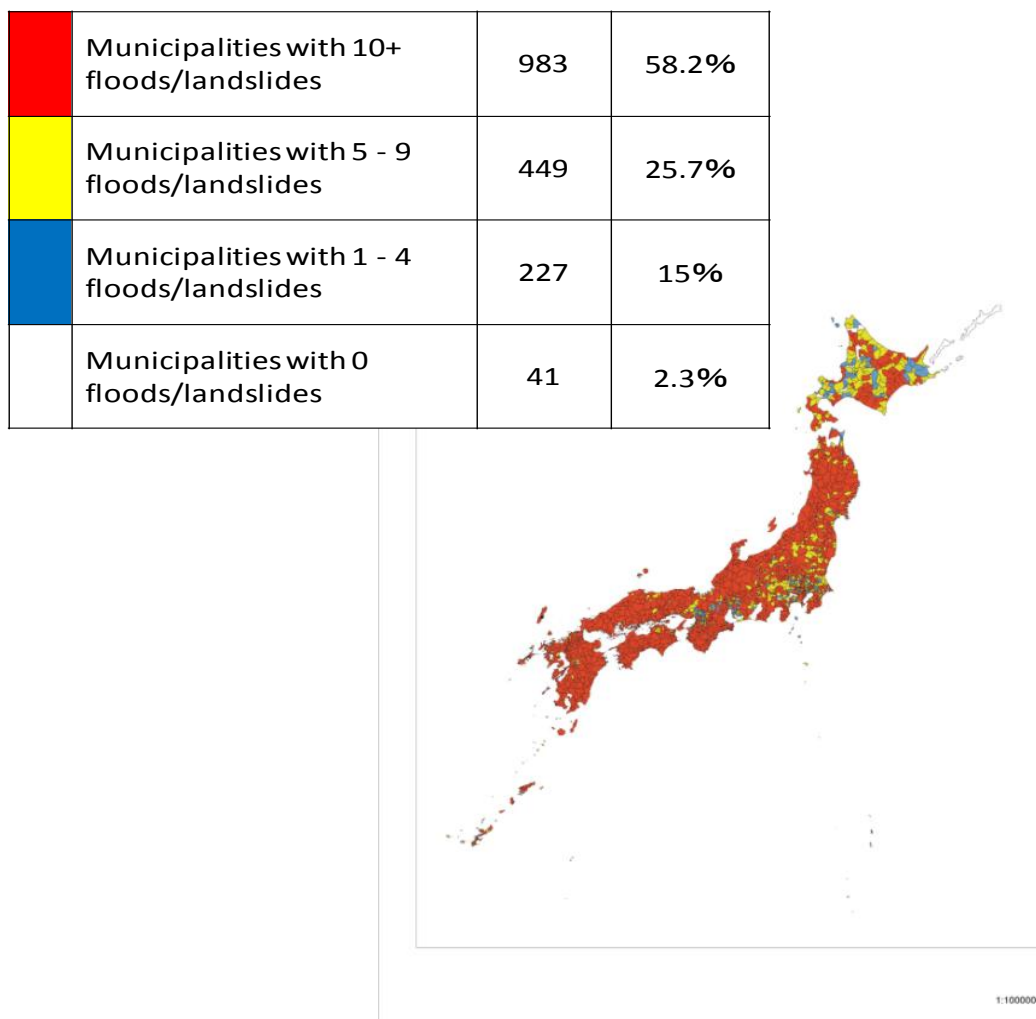
Figure 16: Number of landslide disasters occurring between 2002 and 2011

The average annual number of landslide incidents occurring in Japan over the past ten years (2002 – 2012) is in excess of 1,000. A large percentage of the victims of natural disasters are attributable to landslides, which have caused enormous levels of damage. The causes of landslides can be broadly classified into three categories: “concentrated downpours”, “volcanoes” and “earthquakes”. The concentrated downpour that is still fresh in memory is the North Kyushu Downpour of July 2012, which caused 268 landslides and enormous damage with 23 fatalities/persons reported missing. In addition, in 2011, downpours accompanying typhoon No.12 caused an enormous landslide in the central Japan peninsula area.

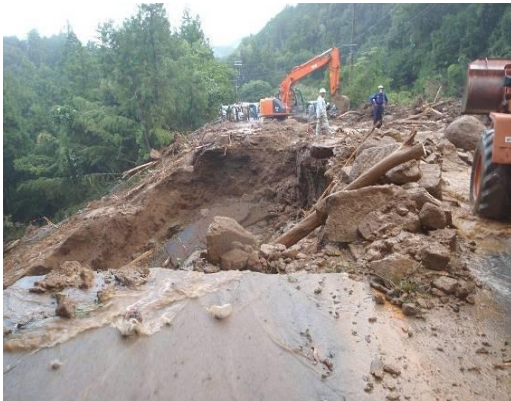
Figure 17: Emergency works on a collapsed road

Together with the approach of the typhoon, and as torrential rains fell over a prolonged period causing waterways to flood and landslides, local construction companies reacted promptly, and devoted themselves to emergency recovery of roads/waterways, etc. and the removal of earthen deposits, etc.

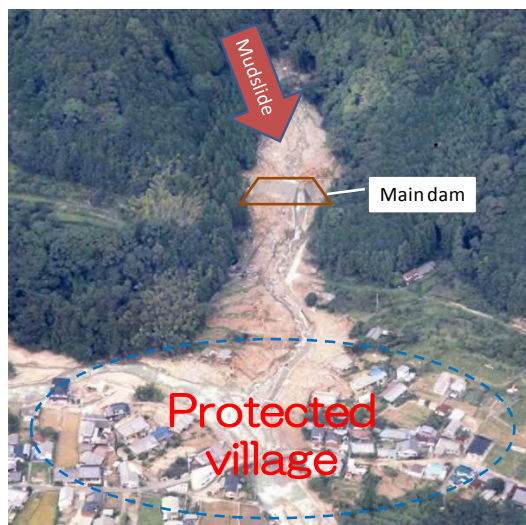
Figure 19: The effects of landslide prevention works (Wakayama prefecture)

Although landslides occurred widely as a result of downpours rainfall, many landslides were trapped by sediment control dams.

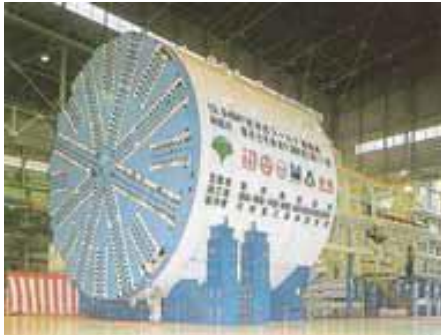
Figure 21: Shield Machine

For the Kanda River Basin in Tokyo, in order to mitigate inundation damage, the 540,000m³ Kanda River/Ring Road No.7 Underground Flood Control Reservoir (Kan-7 Underground Reservoir) was installed (in 1997) under the ground below Ring Road No.7. As a result, inundation damage in the Kanda River Basin was significantly mitigated.

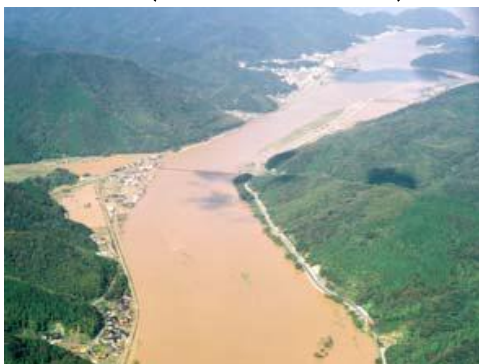
Figure 24: Downstream inundation status (October 2004 flood)

The Maruyama River in Hyogo prefecture of the Central Japan was greatly damaged by floods caused by typhoon No.23 in 2004. The occasion was exploited to implement works such as the raising of levees, the deepening of river channels and the rebuilding of bridges, etc. that would mitigate future flood damage. Further downstream, harmony with the natural environment and scenery is fully considered in the promotion of waterway maintenance, as the area is located within a national park and registered under the Ramsar Convention. The regeneration of large-scale wetland environments in the areas inside the flow of the river aims to secure wetland areas almost as large as those in the past that provided habitat for many storks (about 160ha) and regenerate high quality wetlands.
